# Environmental Risk Analysis In Pertamina Pipe Installation Maintenance Refinery Unit Iv Cilacap On Kali Yasa River, Central Java Indonesia

**ENVIRONMENTAL RISK ANALYSIS IN PERTAMINA PIPE INSTALLATION  
MAINTENANCE REFINERY UNIT IV CILACAP ON KALI YASA RIVER, CENTRAL  
JAVA INDONESIA****Dr. Slamet Isworo<sup>1\*</sup> and Poerna Sri Oetari<sup>2,3</sup>**<sup>1</sup>Environmental Health Study Program, Faculty of Health, Dian Nuswantoro University Semarang.<sup>2</sup>PT. Mitra Adi Pranata. Environmental Impacts Analysis Consultant. Semarang.<sup>3</sup>Graduate School of Environmental Science, Diponegoro University, Semarang, Indonesia.**\*Corresponding Author: Dr. Slamet Isworo**

PT Pertamina Refinery Unit IV Cilacap plans to carry out pipeline maintenance on a cross-country track along 5,300 meters. The activities will be carried out in the form of pipe replacement with the aim of increasing the safety of the distribution pipes. Research is a risk analysis study that aims to identify the existence of negative impacts, predict the level of possible emergence of hazards, evaluate risks that may occur and manage risks that may occur due to maintenance activities of crossing oil f

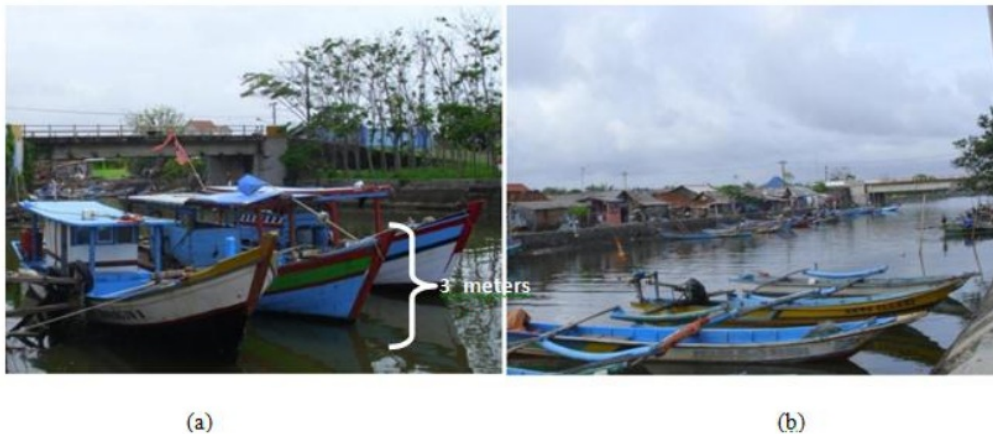
**Figure 2: The ship used by fishermen around Kaliyasa Remarks a). Combrengh ships ship height; 3 meters and b). Fiber Ship.**

The type of vessel used by fishermen around the location of the cross-country pipeline bridge construction activities has a height that is still below the planned height of a cross-country pipe bridge. Types of vessels such as comprengh have a maximum boat height of up to 3 meters from the surface of the water, so ships used by fishing communities around the construction site of cross-country pipelines when crossing the bridge will not cause collisions with pipes. Sail schedule: depart early in the morning at 03.00-06.00 WIB Returns at noon at 13.00-14.00 WIB. The type of vessel used by fishermen around the location of the cross-country pipeline bridge

construction activities has a height that is still below the planned height of a cross-country pipe bridge. Types of vessels such as comprengh have a maximum boat height of up to 3 meters from the surface of the water, so ships used by fishing communities around the construction site of cross-country pipelines when crossing the bridge will not cause collisions with pipes. Vessels that cross the waters of the Kali Yasa River range from 3 meters to the sea schedule: depart early in the morning at 03.00-06.00 WIB at noon 13.00-14.00 WIB (Cilacap Ocean Fishery Port, 2018 and Minister of Mining and Energy of Indonesia, 1997)
